CAT® GENERAL DUTY UNDERCARRIAGE VS ITR

PEDJ1485

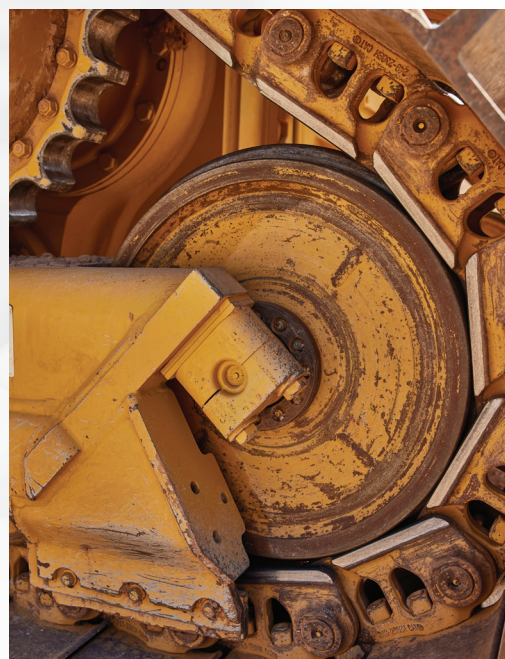
Cat® joints use premium seals that keep oil in the joint longer for enhanced track life. At the end of the test that substantiates this claim, ITR bushings were 48 percent worn. The link assembly joints went dry, causing the track to fail at 2,936 hours. As the track extended from dry joints, the track recoil spring extended as much as possible to accommodate it.

At 2,936 hours, when the test ended, the Cat bushings were only 18 percent worn. The link wear percentage was only 29 percent, and the joints had oil in them. Caterpillar estimates that the Cat link assembly would have lasted up to 10,000 hours.

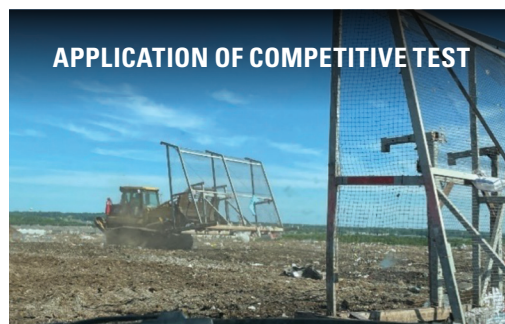
APPLICATION OF COMPETITIVE TEST

The testing team outfitted a D6T LGP with new ITR undercarriage on the left side and new Cat General Duty undercarriage on the right side. The undercarriage test took place in a landfill application and lasted 2,936 hours. Installed components included rollers, idlers, segments and track. The test occurred from December 2021 through March 2024 in the Midwest region of the United States. The local Cat dealer PSSR and the Undercarriage Product Group team monitored the test on a regular basis.

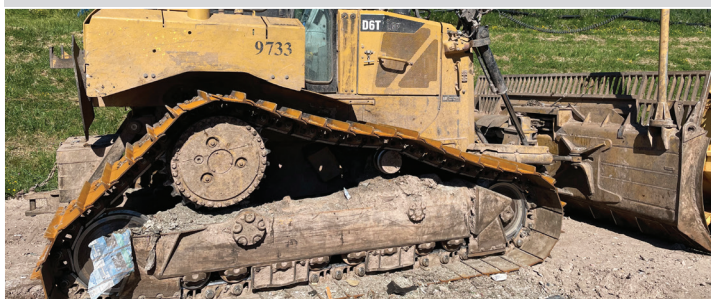
CATERPILLAR

- Final inspection revealed that the Cat track had 70% of life remaining.
- The Cat track would have lasted approximately 10,000 hours.

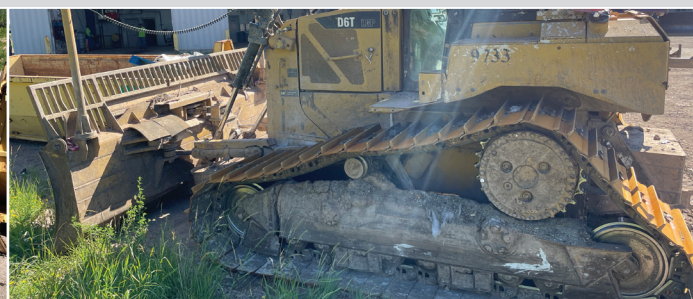
- At 1,011 hours, an onsite inspection revealed that the ITR tracks were beginning to show signs of track pitch extension. The customer could wiggle them by hand.
- The customer extended the frame twice before ending the test at 2,936 hours because the track was too loose.

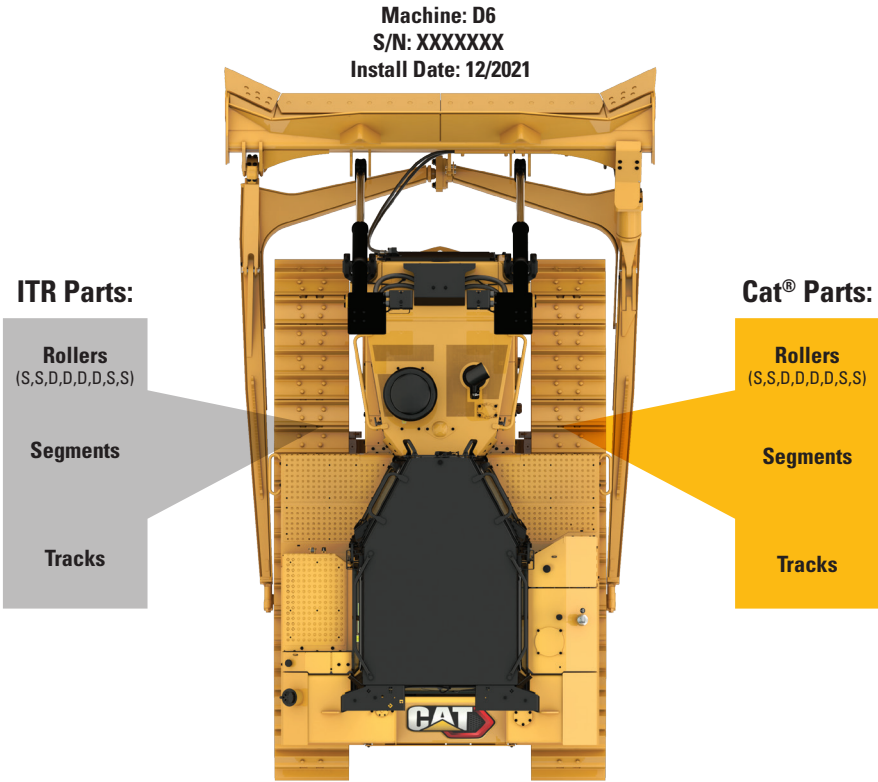
INSTALLED IRON: CAT AND COMPETITION

The testing team compared and analyzed the Cat General Duty and ITR components visually, dimensionally and mechanically. Data shows the Cat joints remained lubricated while the ITR parts were dry at the end of the test (2,936 hours). Dry joints accelerate wear over time and are caused by metal-on-metal connection. ITR track joints had no oil and “could be wiggled by hand” throughout the test, according to the customer.
