# CAT® HDXL UNDERCARRIAGE VS TREK (DCF)

## KEY ADVANTAGE

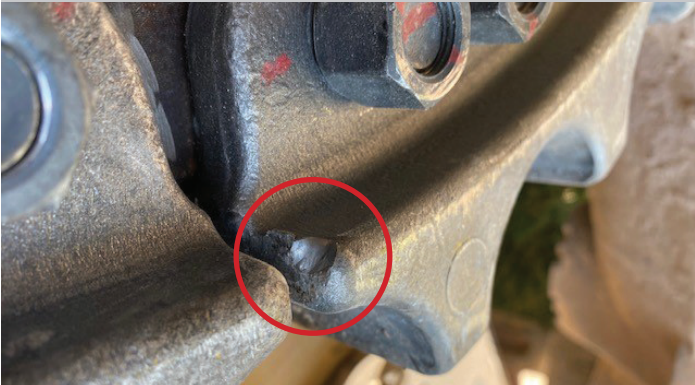
Trek (DCF) segments hit each other, loosening them over time.

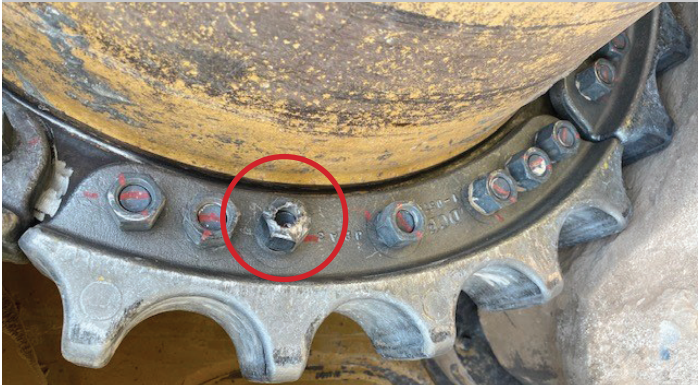
Trek (DCF) bolts became loose from wear.

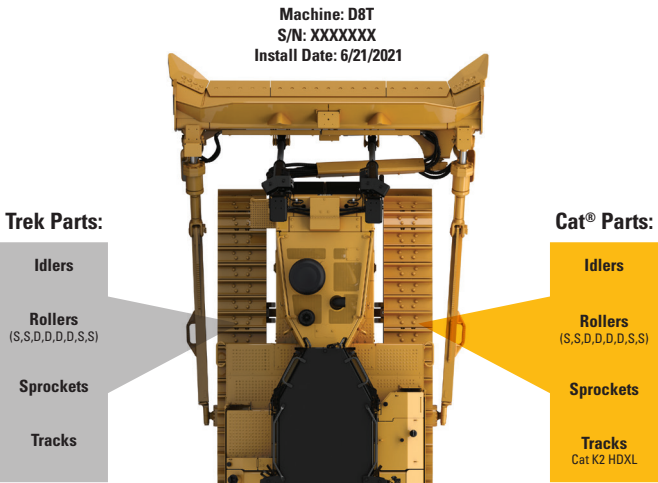
INSTALLED IRON: CAT AND COMPETITION

Cat hardware was used on all components (excluding Trek Master Bolts)

The testing team outfitted a D8T with a new Trek undercarriage on the left side and a new Cat HDXL undercarriage on the right. Installed components included rollers, idlers, segments and track. Cat hardware was also installed on both sides (excluding Trek Master Bolts). The test began in February 2022 and was at the halfway point in October 2024. At that time, the undercarriage had accumulated 3,400 hours in an oil field pad prep application. The machine continues to run in an application considered moderate abrasion and moderate impact. The local Cat dealer PSSR and the Undercarriage Product Group team are monitoring the machine on a regular basis.
